PUBLIC HEARING BOARD OF HOUSING QUALITY APPEALS CITY HALL McCLOSKEY CONFERENCE ROOM June 08, 2011 4:00 P.M.

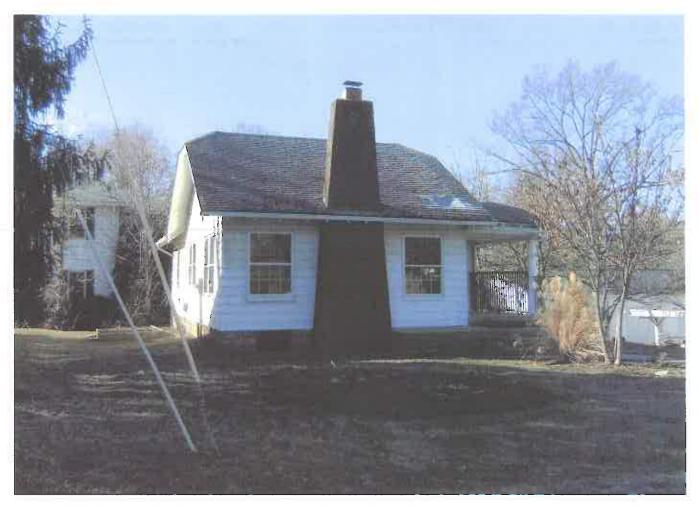
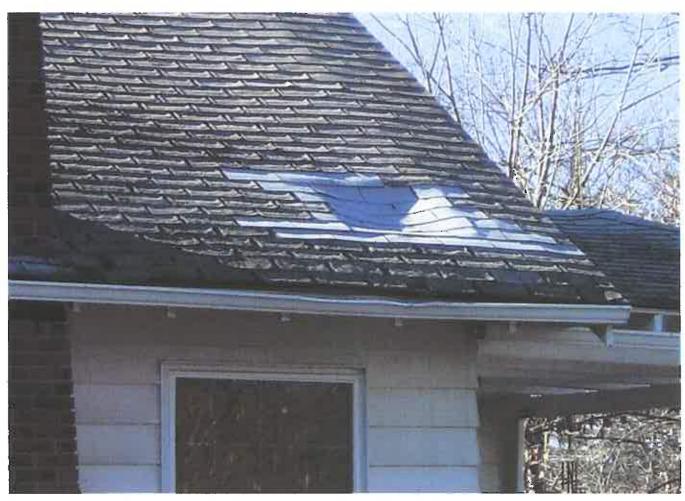
Repair or replace damaged or deteriorating roofing (near northeast corner). This is to be done in a workmanlike manner and includes but is not limited to damaged or deteriorating roofing material, sheathing, and all structural members. PM-303.4 & PM-303.7

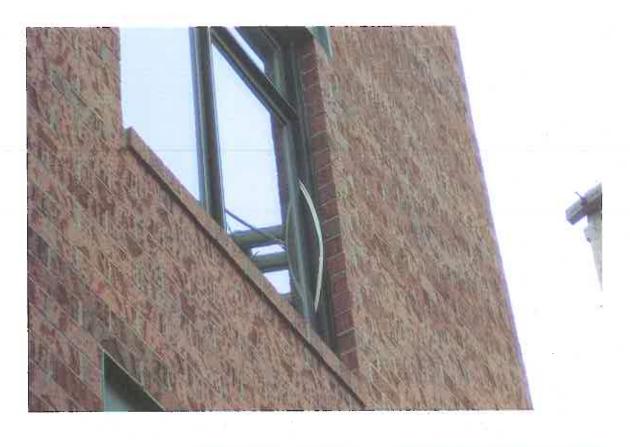
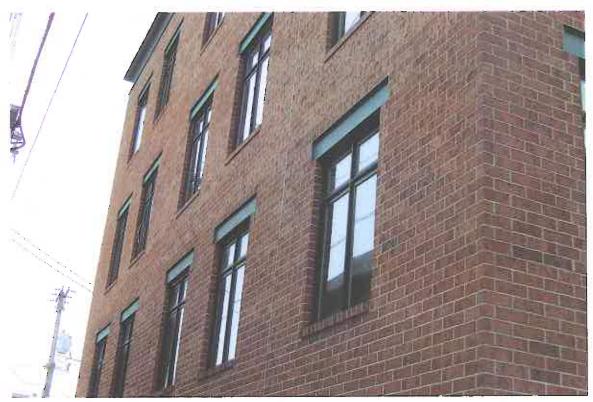
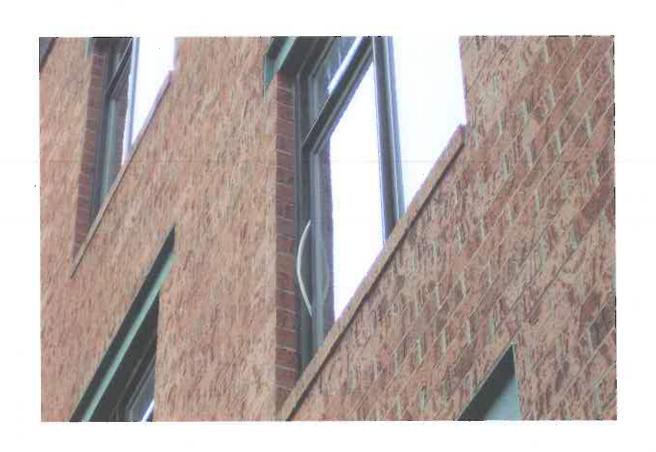
South Bedroom:

Replace or properly repair the rotten window frames so that the windows function as intended. Every window shall be capable of being easily opened and held in position by its own hardware. PM-303.13.2
